Subject: Final Report of the KCVI Rehabilitation Project

CIVL 460: Civil Engineering Design and Practice IV

Draft Final Report

Stable Designs

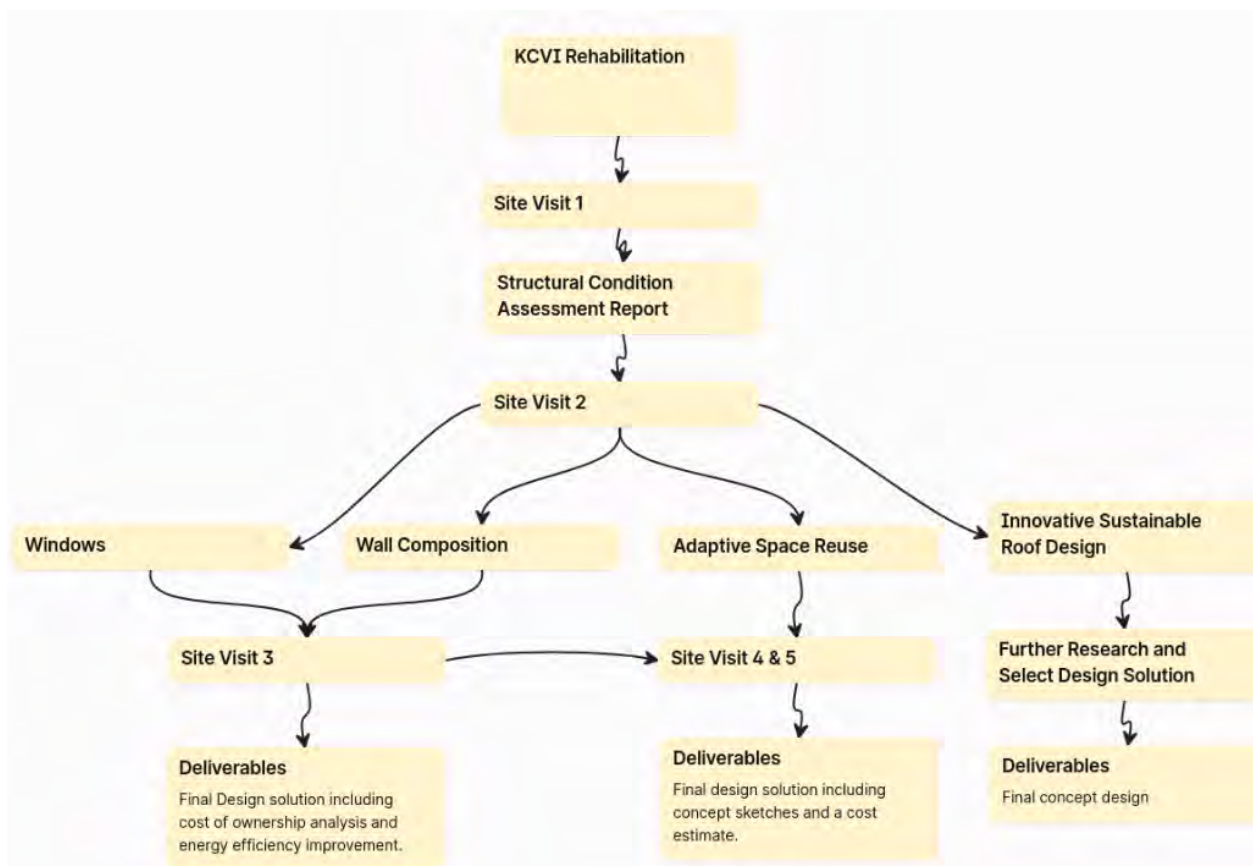
Figure 3: Scope Mind Map, Illustrating the Flow of the Project

The client has specifically requested to focus on the first three scope components, to ensure an energy efficient building envelope and to adapt the space for its intended use. The fourth scope component has been developed since the roof has reached the end of its lifespan, so imminent replacement is necessary. Figure 3 outlines the project scope in a visual format.

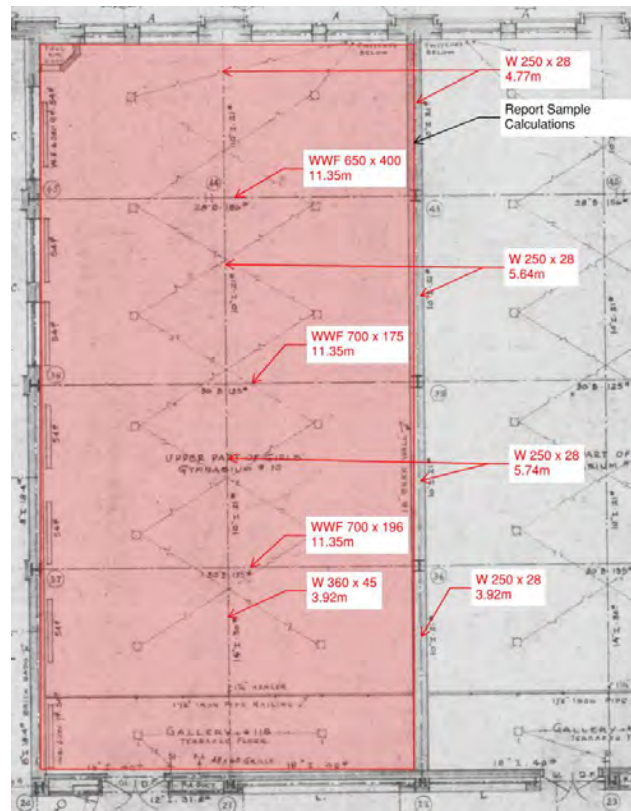
Figure 15: A figure showing the area of focus for analysis and highlights the beams under analysis.

The location of each beam relative to each other, the beam metric name, and length is noted in Figure 15.

The floor system consists of eight W-section beams (w), and three built-up sections (WWF). The beams that span 11.35 metres (WWF), experience a point load from the overlying steel beams located in the middle of the floor system.

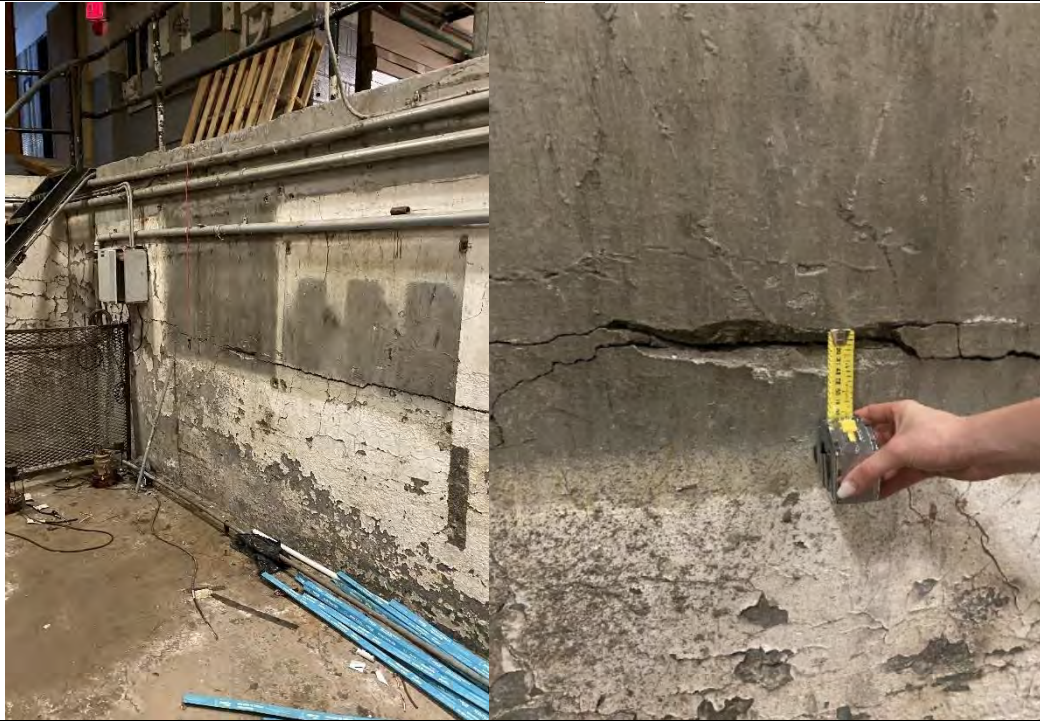
Floor 0 – Deficiency #1

Large crack along Mechanical Room pit wall. The maximum thickness of this crack is 40mm, and extends over 3000mm in length.

Medium

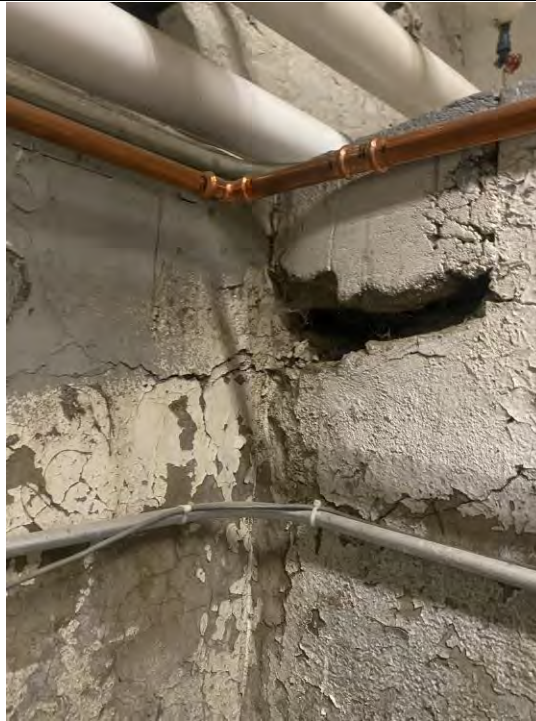
Floor 0 – Deficiency #2

Thick crack/hole along Mechanical Room pit wall.
The maximum thickness of this crack is 120mm wide, and 340mm long.

Medium

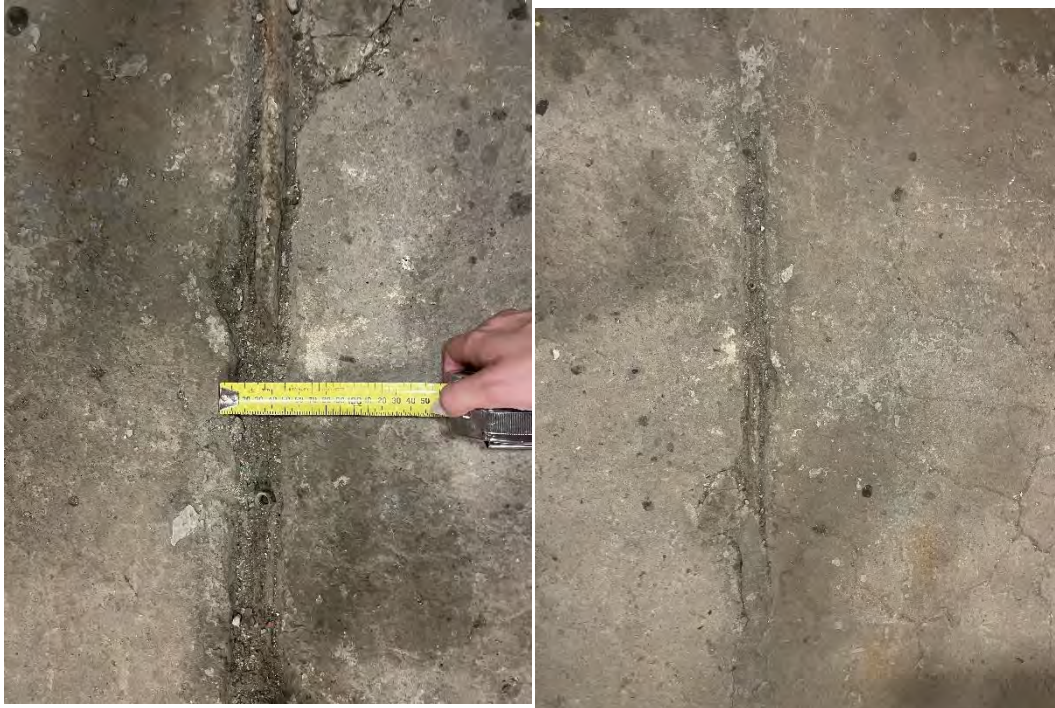
Floor 0 – Deficiency #3

Exposed rebar along the Mechanical Room floor. The maximum thickness of the exposed rebar and floor cracking is 50mm, and the length extends approximately 780mm

Low

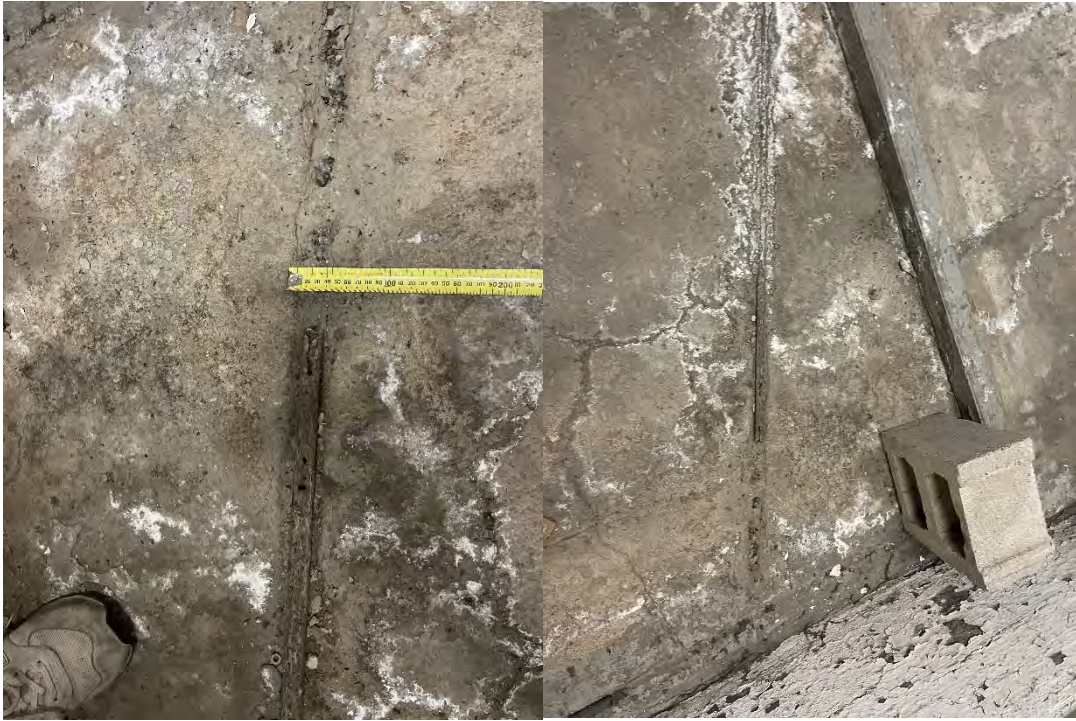
Floor 0 – Deficiency #4

Exposed rebar along the Mechanical Room floor. The maximum thickness of the exposed rebar and floor cracking is 40mm, and the length extends approximately 680mm.

Low

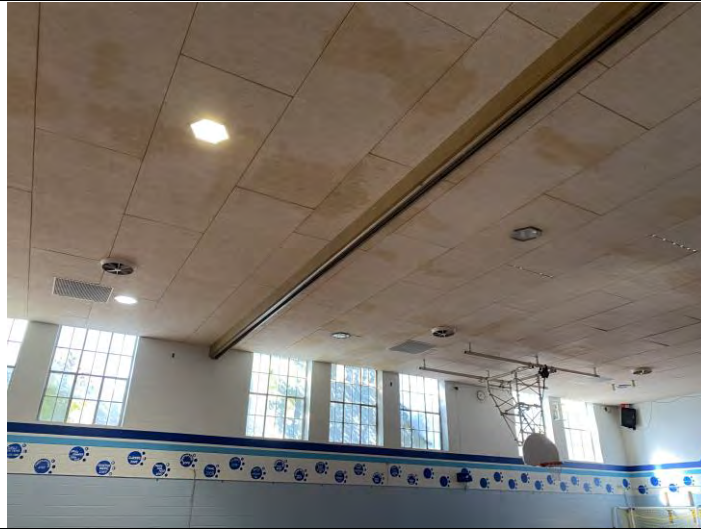
Floor 0 – Deficiency #5

Broken windows along the West side of the Gymnasium windows.

Low

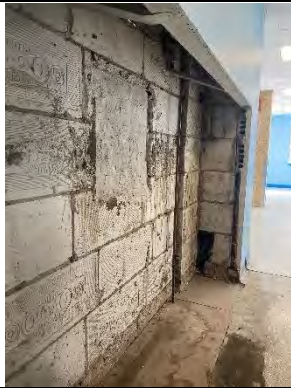
Floor 1 – Deficiency #1

Large man-made hole in wall, exposing concrete block interior. Minor efflorescence on floor below wall.

Low

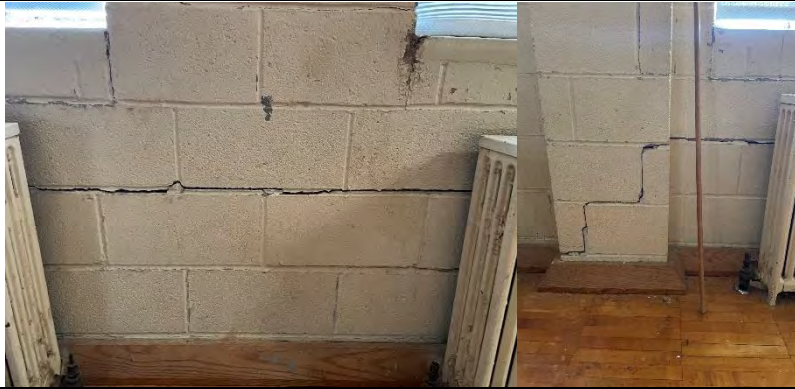
Floor 1 – Deficiency #2

Horizontal and vertical cracking along mortar.

Medium

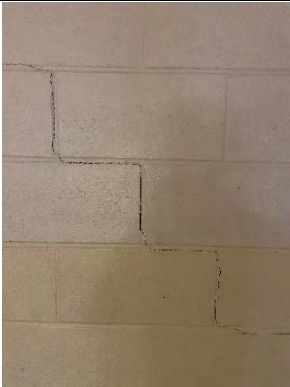
Floor 1 – Deficiency #3

Description:	Horizontal and vertical cracking along mortar. Sections of cracking appeared to extend through the wall.
Recommendation:	Repointing.
Level of Importance:	Medium

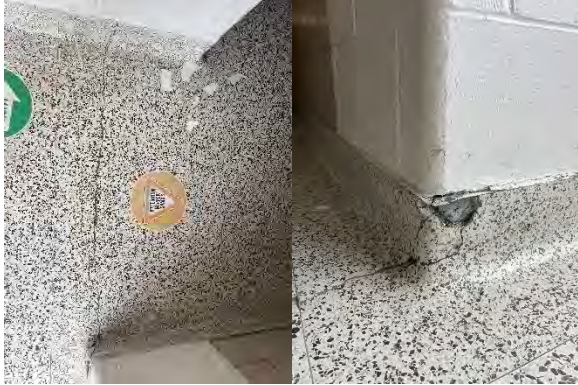
Floor 1 – Deficiency #4

Description:	Hairline cracking and spalling along concrete flooring.
Recommendation:	Replace flooring. Further inspection required to assess the structural integrity.
Level of Importance:	Medium

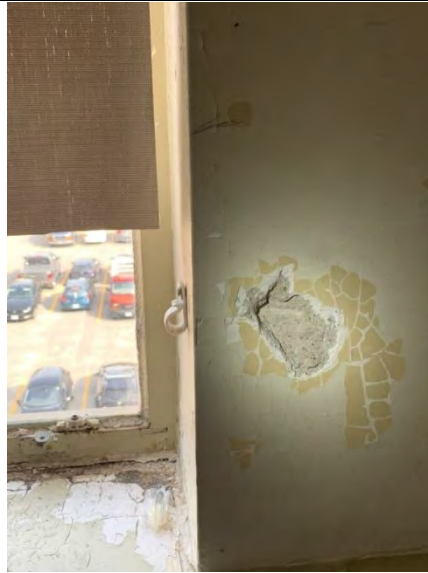
Floor 3 – Deficiency #1

In the classroom labelled as 317 on the drawings, on the exterior wall, there was a concrete hole that could indicate potential spalling. Note that this section of the building was made of concrete from what we could see.

Low

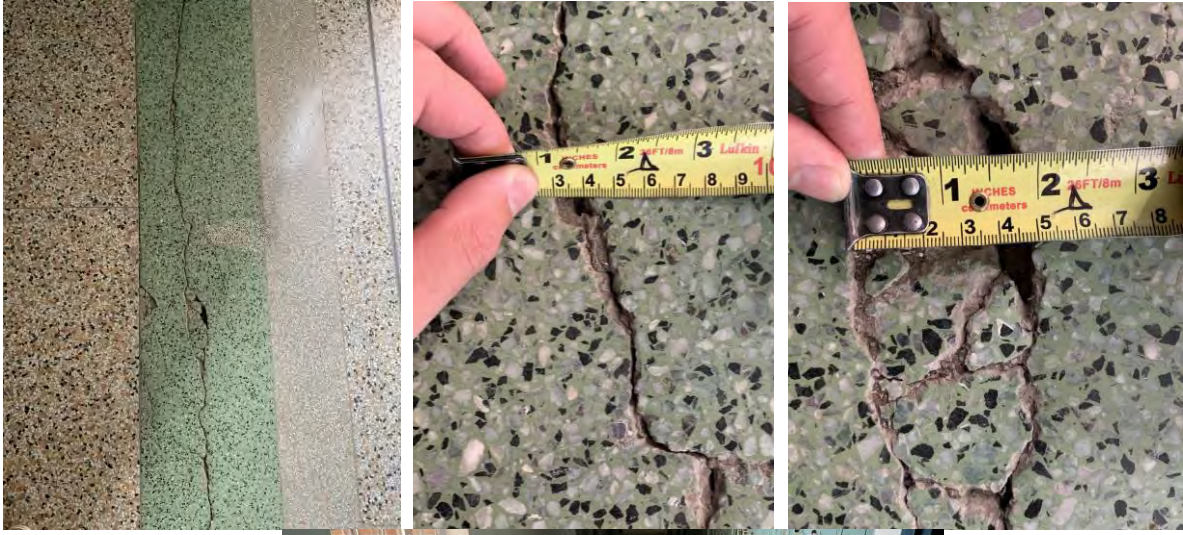
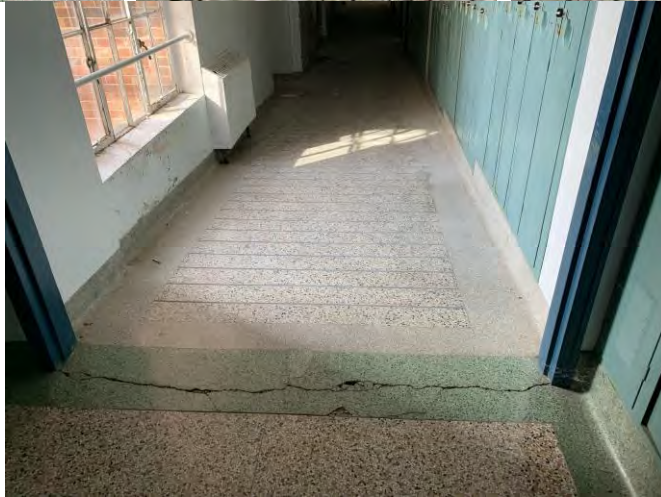
Floor 3 – Deficiency #2

At the end of this ramp to the point that connects with the floor that is level (the joint), there was a significant crack in the concrete floor. 50 mm at its largest.

Medium

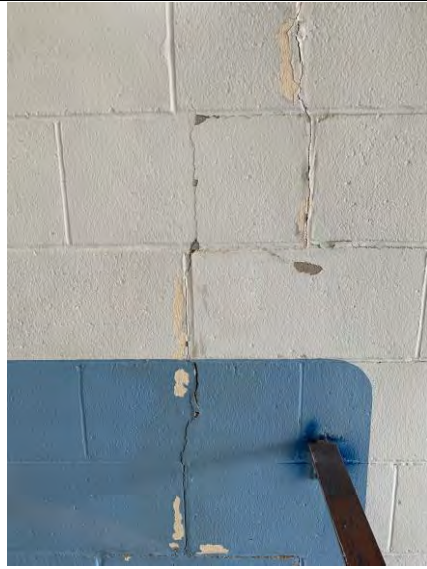
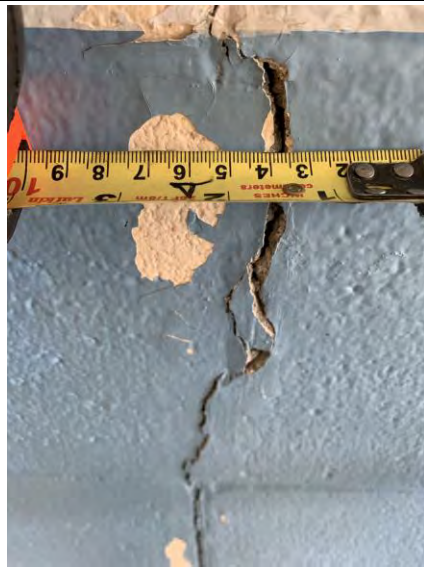
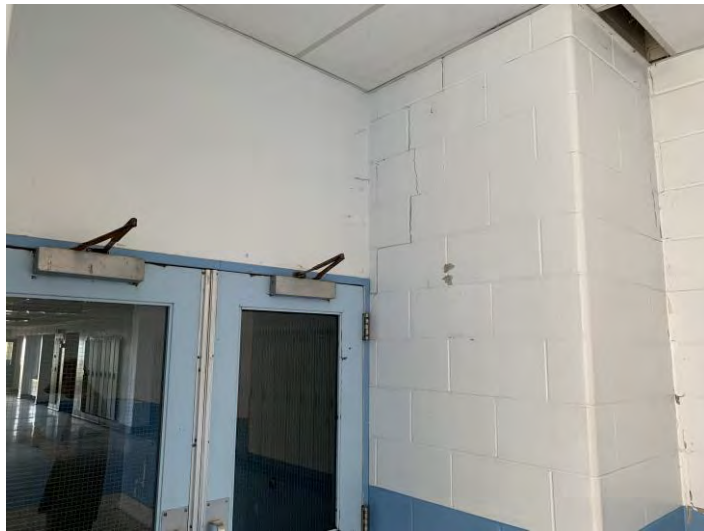
Floor 3 – Deficiency #3

Note that the floor plan for this area was not correct. On the north exterior wall of this northeast stairwell, there was a large crack running through the masonry blocks. Note that there were multiple areas of these sorts of cracks within this area that have all been included as Deficiency #3. 5 mm at its largest.

Low

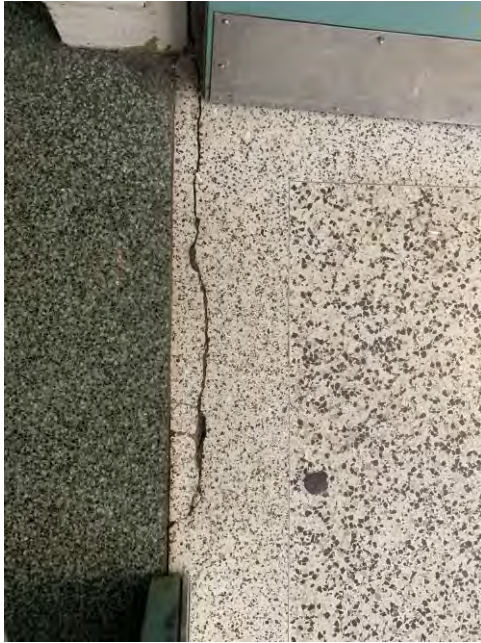
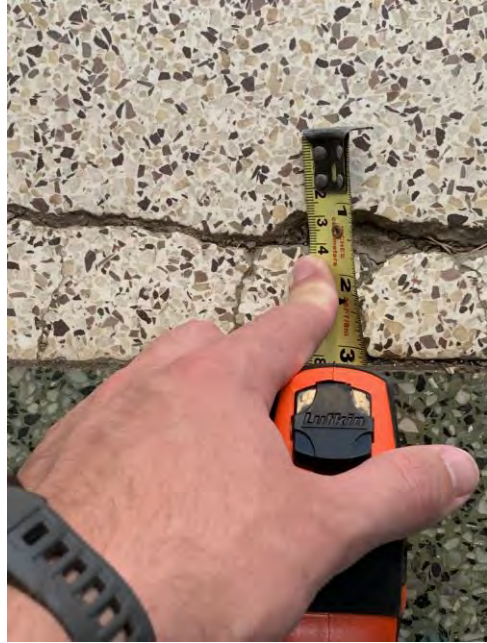
Floor 3 – Deficiency #4

When entering the northeast stairwell, walking through the doors, there was a crack within the floor. 10 mm at its largest.

Low

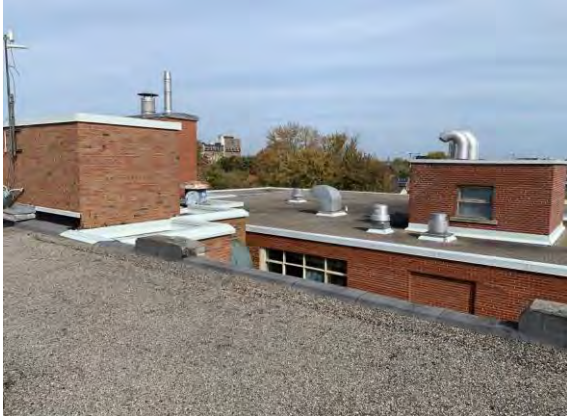
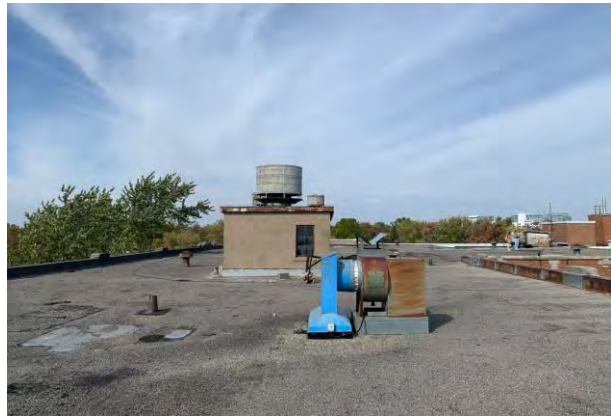
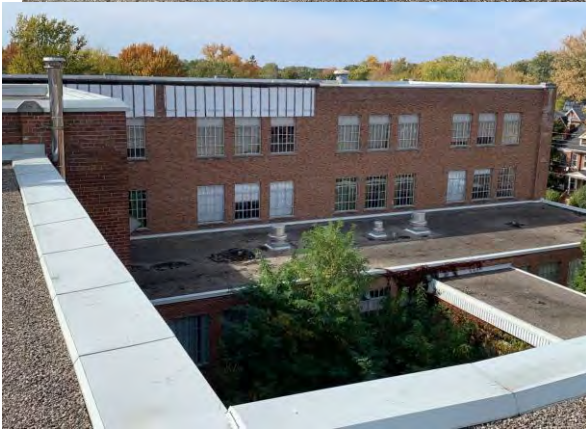
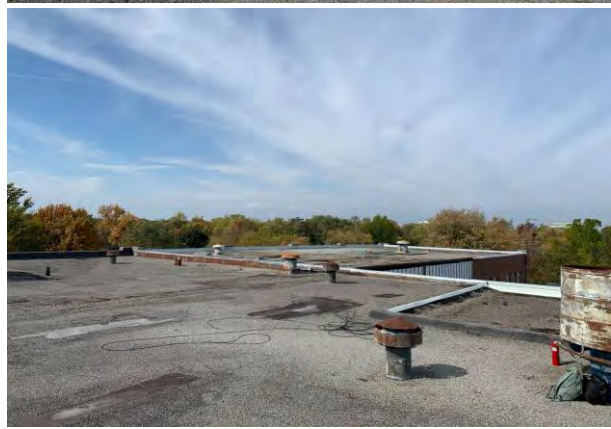
Roof – Deficiency #1

Description:	The roof consists of several different additions with varying heights and sizes. All roof assembly systems are conventional built-up roof assembly (BUR). Built up parapets and metal flashing surround the perimeter of each roof. Internal roof drains are the typical drainage system for each roof. All the roofs on different additions have reached the end or are nearing the end of their theoretical life cycle of 22-25 years. See Appendix C for more information regarding a roof condition assessment.
Recommendation:	Replace roof and incorporate additional energy efficient improvements as indicated in the coming report.
Level of Importance:	Urgent

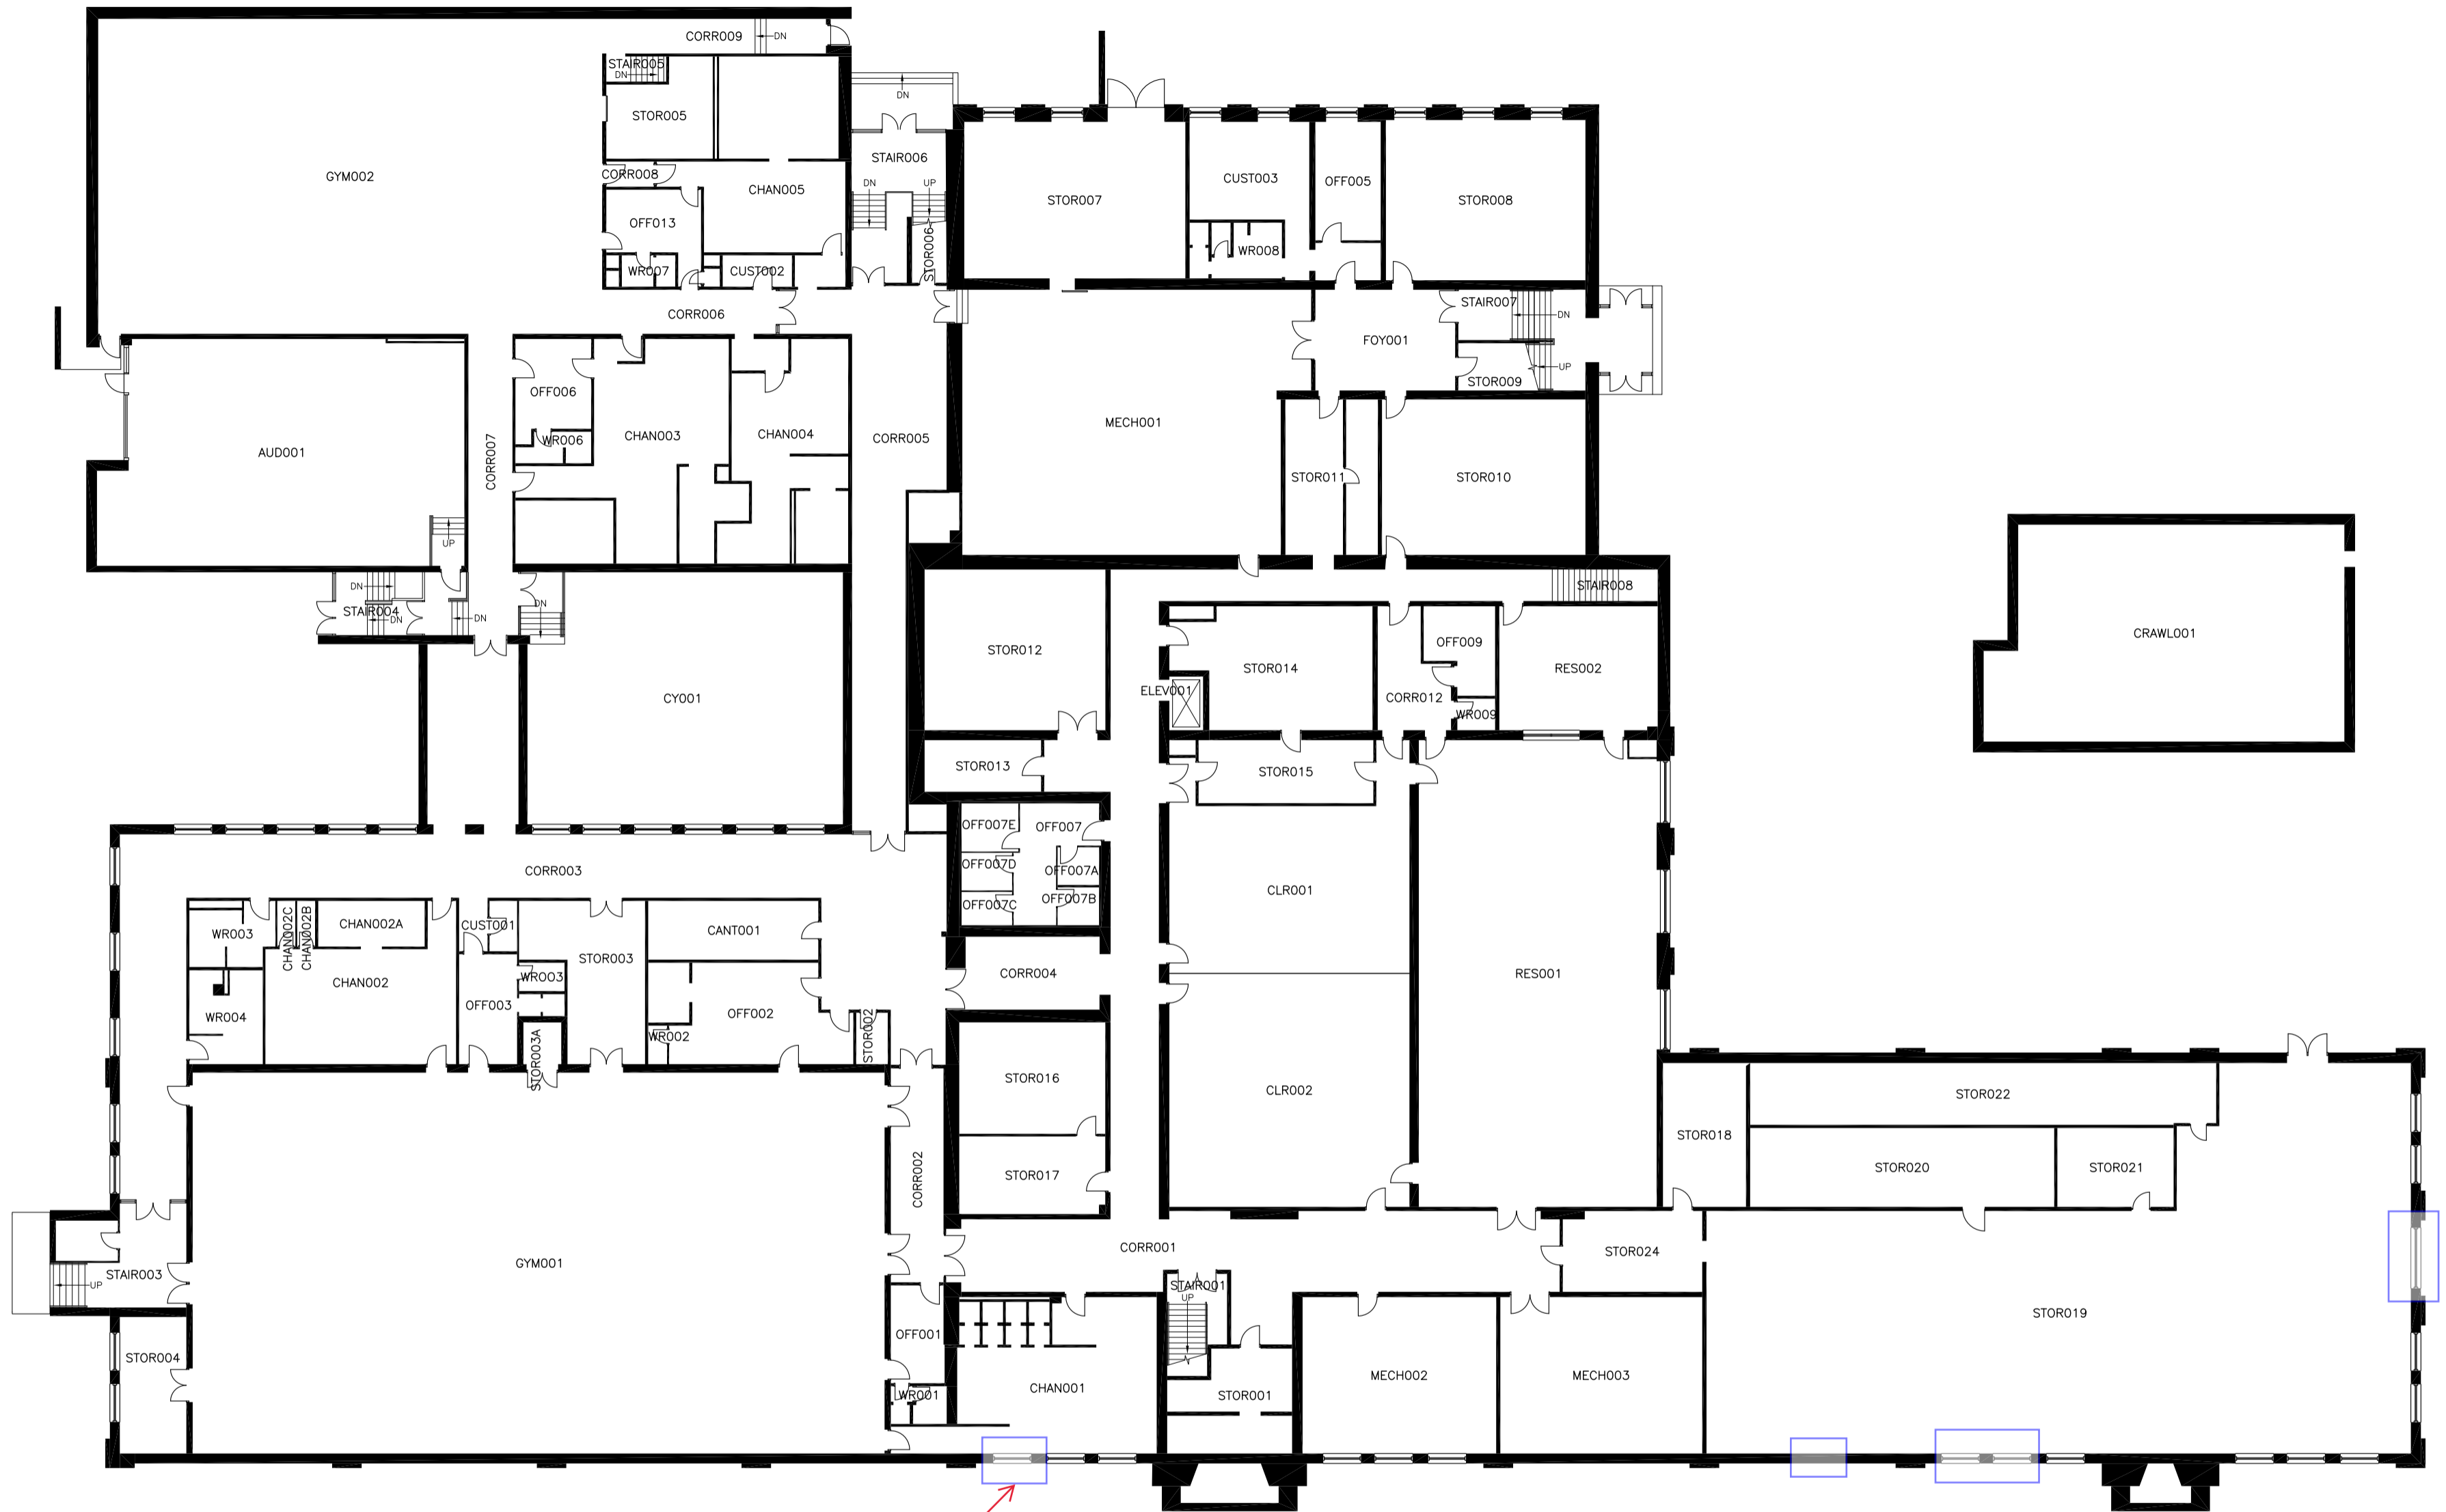
Appendix D: Supporting Documents for Windows Scope Component

Window Broken (TYPICAL)

The windows in the existing building are in poor condition and some panes are broken, which results in significant heat loss and energy efficiency issues. Since KCVI is classified as a historical building there are additional challenges involved with the retrofit and replacements. In this report, design options for the windows will be developed and a solution will be proposed based on the identified criteria and their relative importance. This report also includes a final cost estimate, a cost of ownership analysis, and an energy efficiency improvement rating.

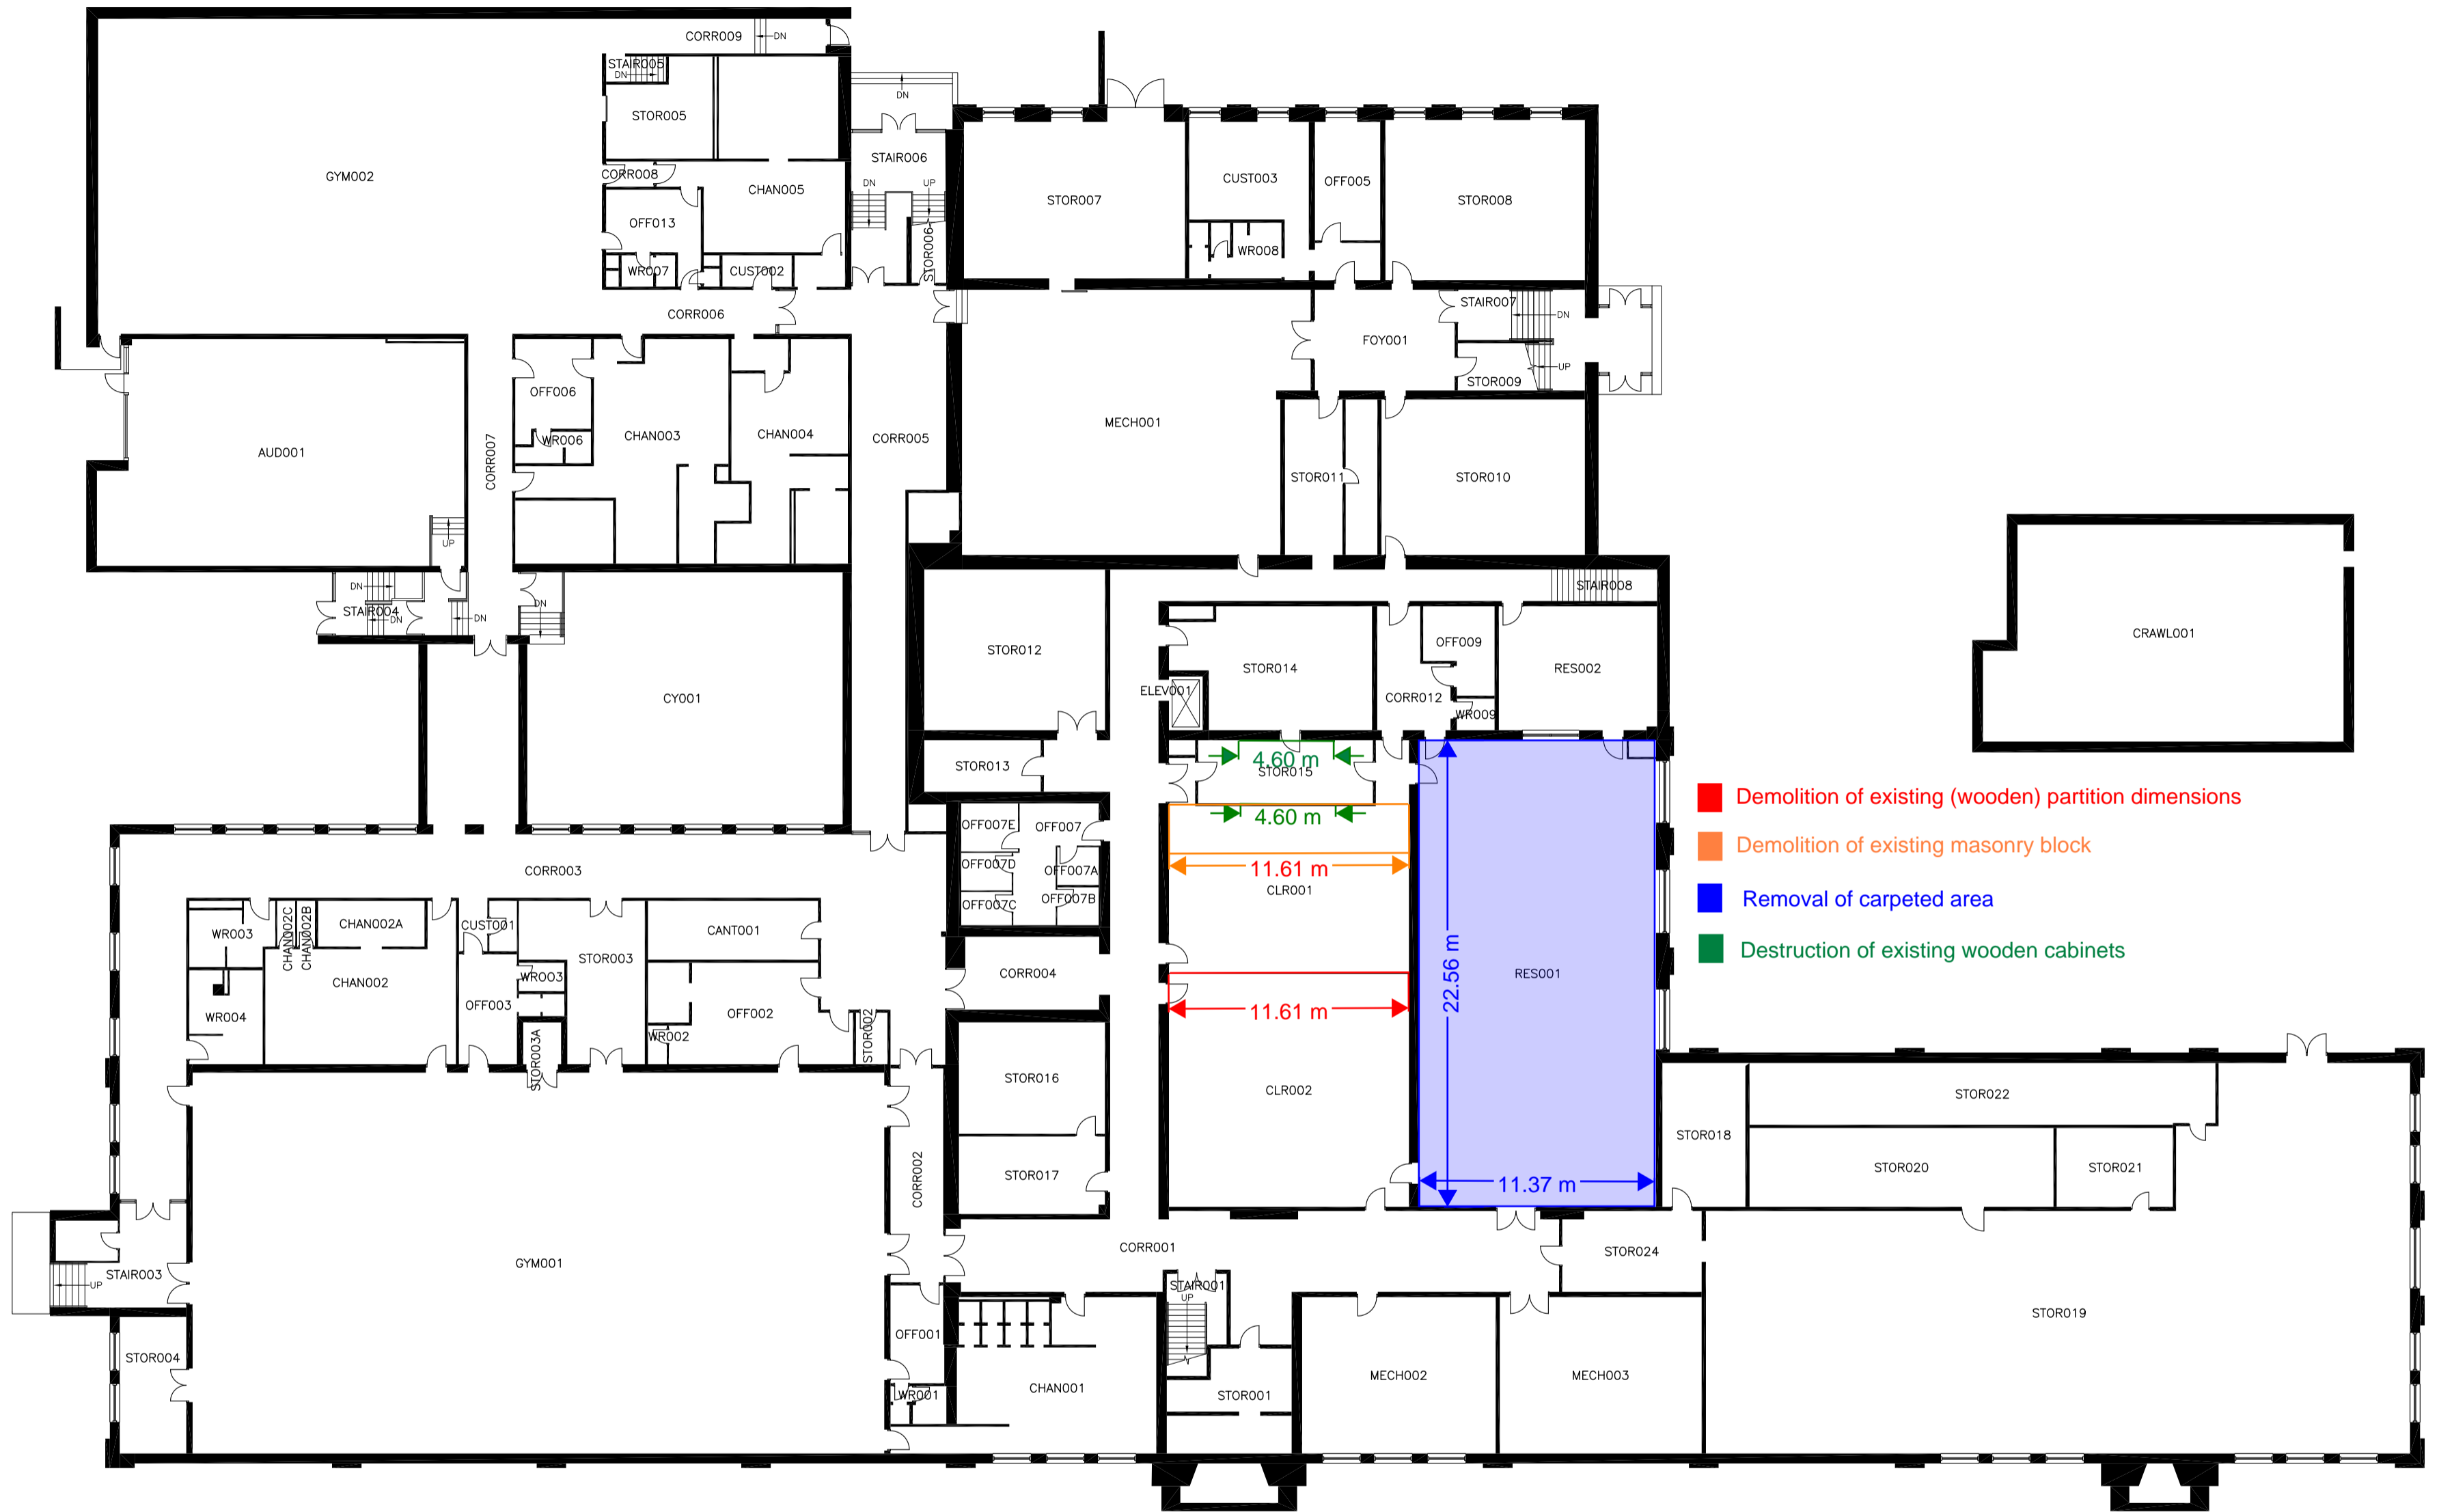
PLAN OF FIRST FLOOR

- Demolition of existing (wooden) partition dimensions
- Demolition of existing masonry block
- Removal of carpeted area
- Destruction of existing wooden cabinets

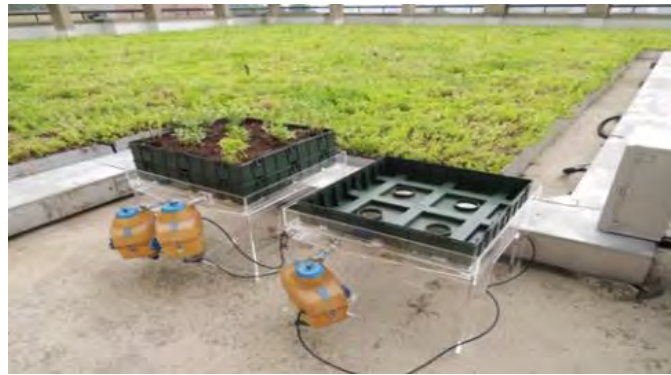
Figure 26: Green-Blue Roof at the Chungwoon Middle School (Shafique et al. 2016)
